INCLUSIVE SPORTS FACILITIES ASSESSMENT PROJECT

State of Play Report

FEBRUARY 2021

CITY OF
Port Adelaide Enfield

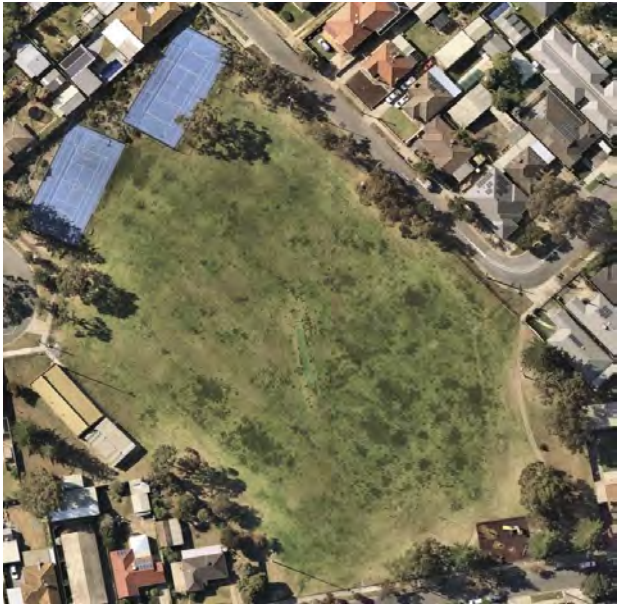
ALMOND TREE FLAT RESERVE

- Building in very poor condition. Significant quality issues identified
- Good adequate internal storage
- Player amenity in very poor condition and do not meet unisex standards.
- Community courts in good condition. Estimated court surface renewal is long term (6-10 years)

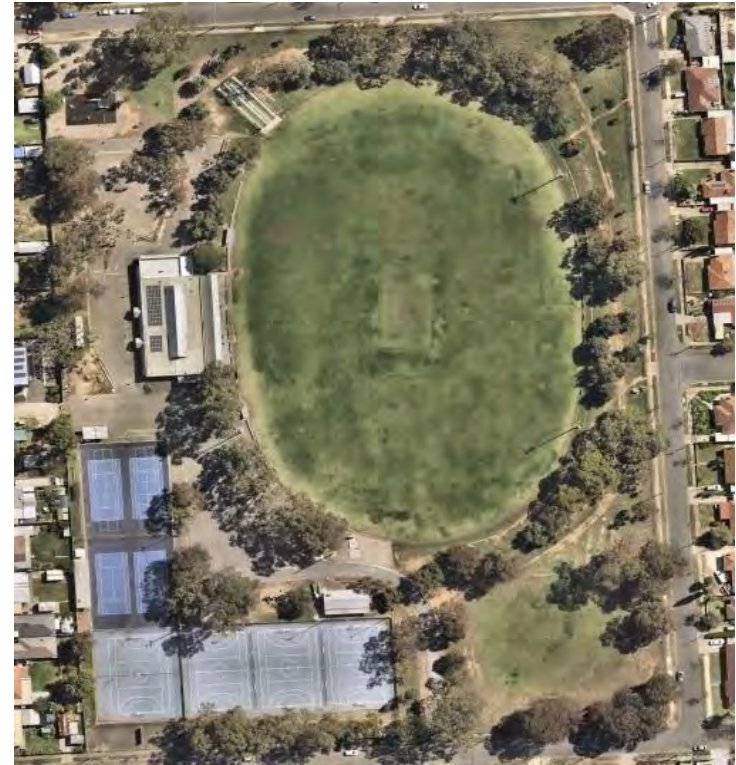
- Football/Cricket building in good condition (some wear)
- Tennis building in very poor condition and lacks storage
- Futsal Building in moderate condition and has been renovated in the last 2 years to support futsal activities
- Player amenities in Football/Cricket building in good condition
- Centre wicket is turf and in good condition
- Tennis (4) and Futsal (4) courts in moderate condition with cracking occurring and evidence of pooling in areas

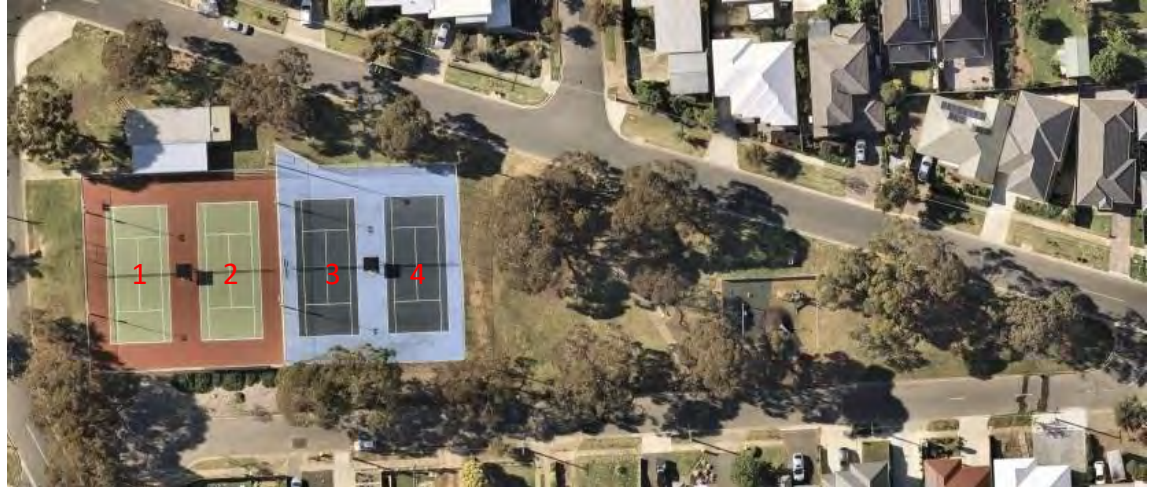
- Single room club facility with an outdoor area covered in with a shelter in moderate to good condition.
- Very limited internal storage areas with a small shed outside.
- Courts 1 & 2 in excellent condition
- Courts 3 & 4 in moderate condition - small surface cracks and pooling evident in areas
- Fencing is in average condition - has slack mesh, curling at base and in some parts has rusted mesh. Will need replacing in 3-5 years. Court 3 & 4 fencing is worse.

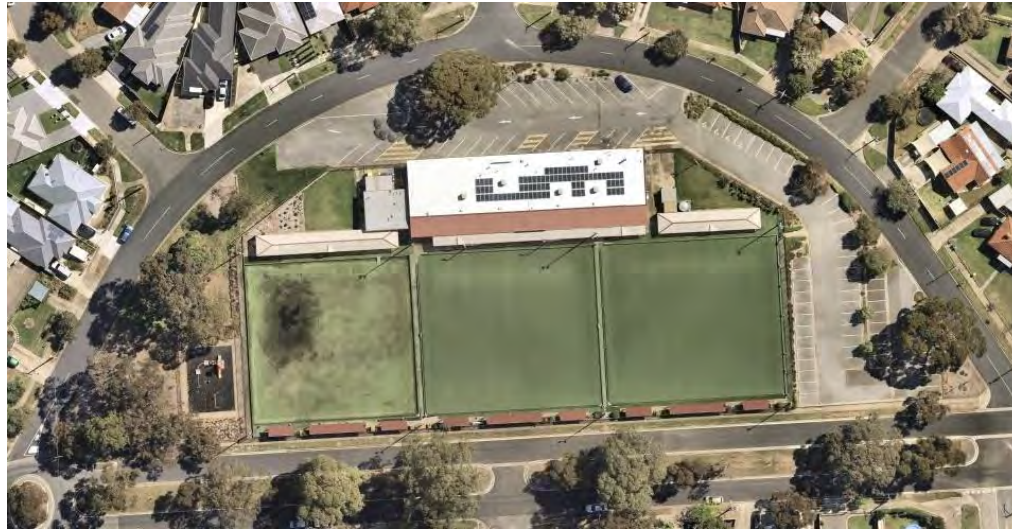
- Building in good condition (some wear)
- Western bowling green in good condition with noticeable wear. Other 2 bowling greens in excellent condition
- Site fencing in excellent condition

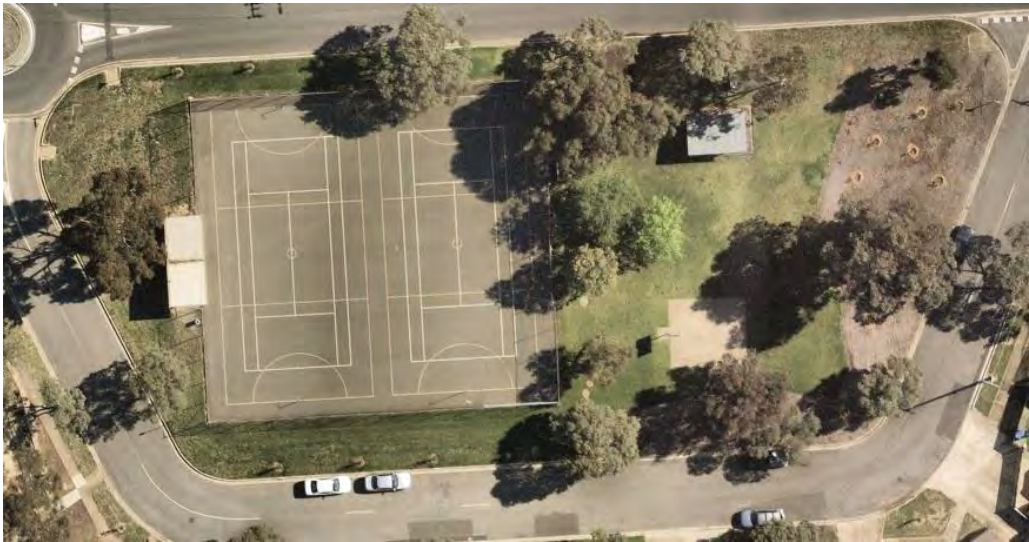
- Courts are in good condition and acceptable for community use or training purposes
- If shelter/building structure is no longer needed, remove it so it doesn't become a safety issue

PLAYING FIELD / COURT AREAS		
ASSET	DESCRIPTION	RATING
Surface	Asphalt	2
Drainage	No evidence of pooling	2
Site Fencing	Slack and rusted in paces	3

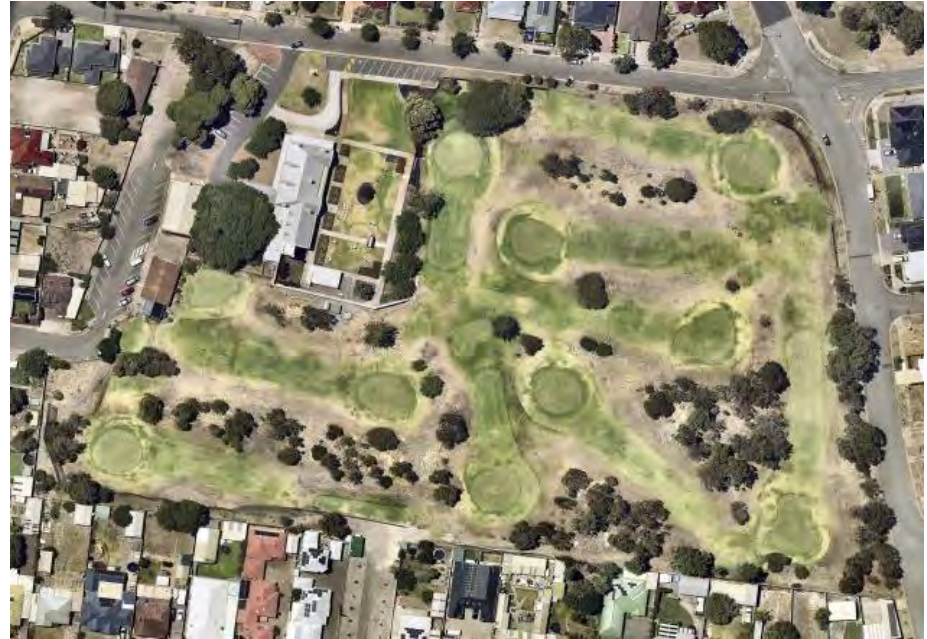
- Small pro shop with seating and toilets
- Public toilets in moderate condition but need upgrading (remove urinal)
- Golf greens in good condition
- Site is not fully fenced – can be accessed by the community

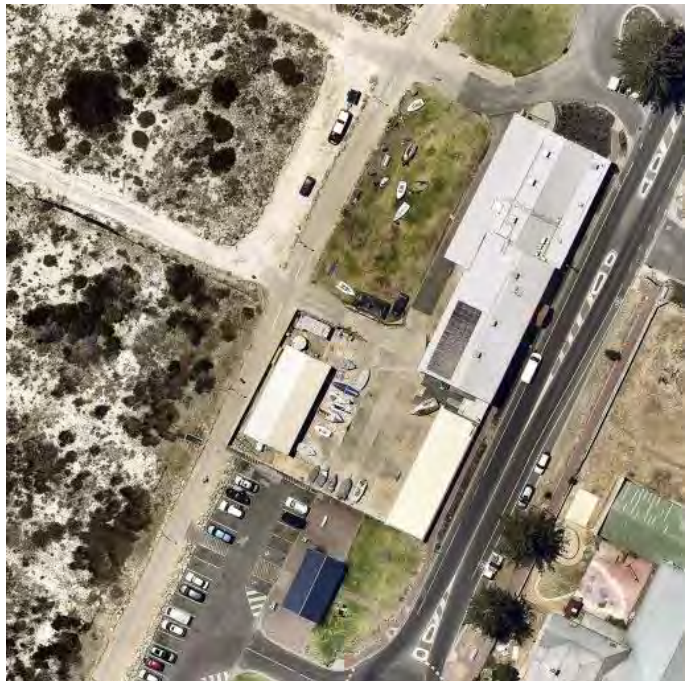
- Kitchen and Social area in excellent condition
- Building overall is in good condition (some wear)
- Changerooms contain unlockable cubicles
- No Lifts to second floor

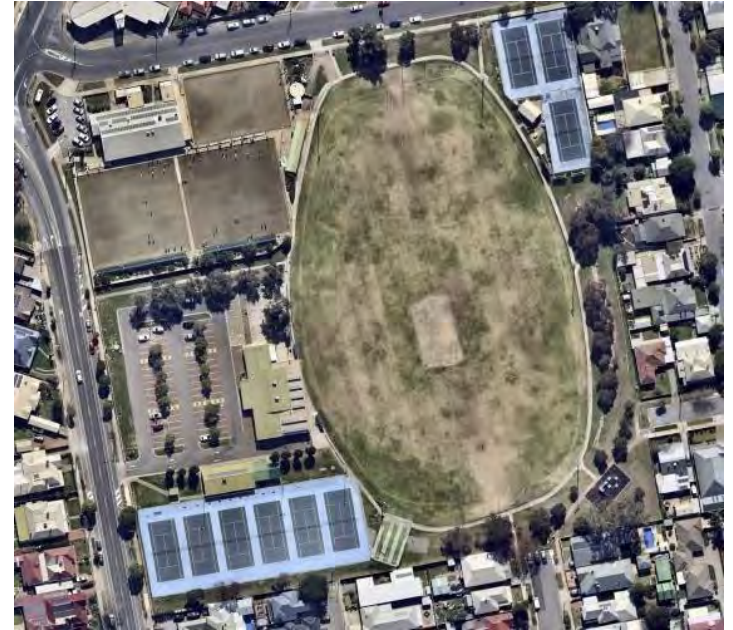
- Football/Cricket building in poor condition (multiple issues)
- Player amenities in Football/Cricket building in good condition
- Player benches on field in excellent condition (as new)
- Centre wicket is turf and in good condition
- Semaphore Tennis courts in moderate condition with cracking occurring and evidence of pooling in areas
- Port Adelaide Tennis club courts in good condition

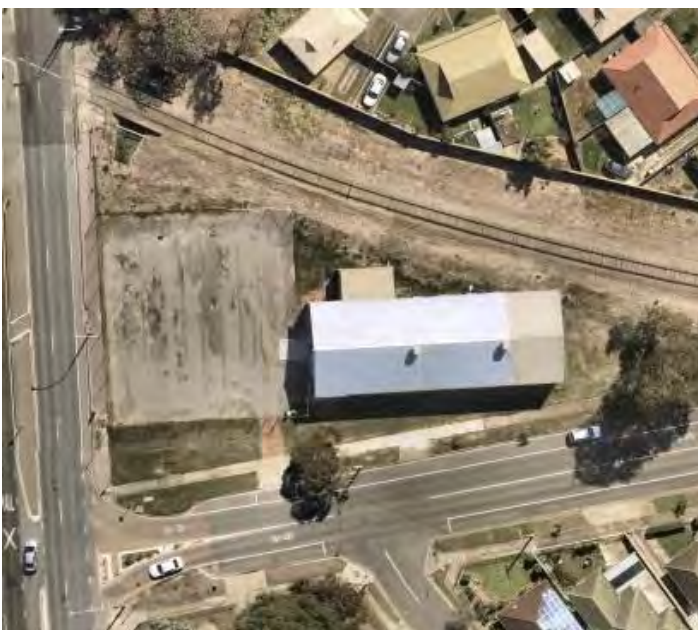
- Kitchen is a servery only and is in poor condition
- Social area is upstairs and in moderate condition but very small
- Overall, the building is in poor condition with multiple issues identified
- Flooring in Gymnastic Hall in excellent condition

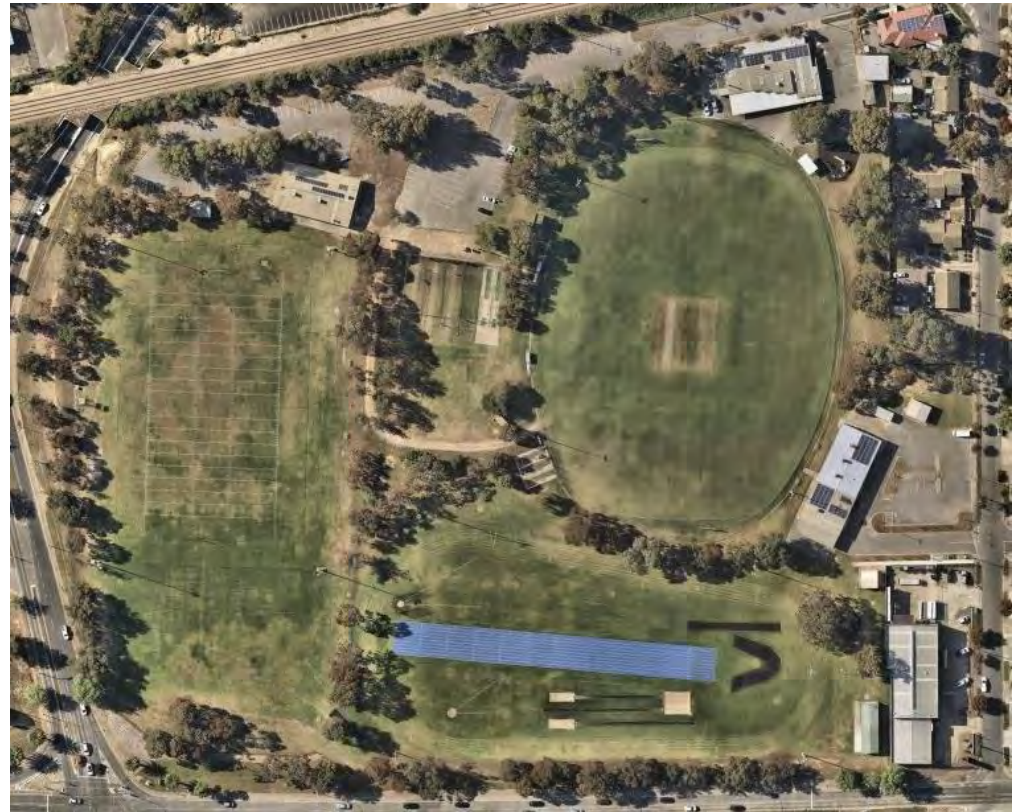
- Rugby building in poor condition (multiple issues)
- Player amenities in Football/Cricket building in moderate condition
- Athletics building in excellent condition
- Turf centre wicket is in good condition
- Cricket training net facilities both in moderate condition
- AFL/Cricket scoreboard in very poor condition (safety issues identified)

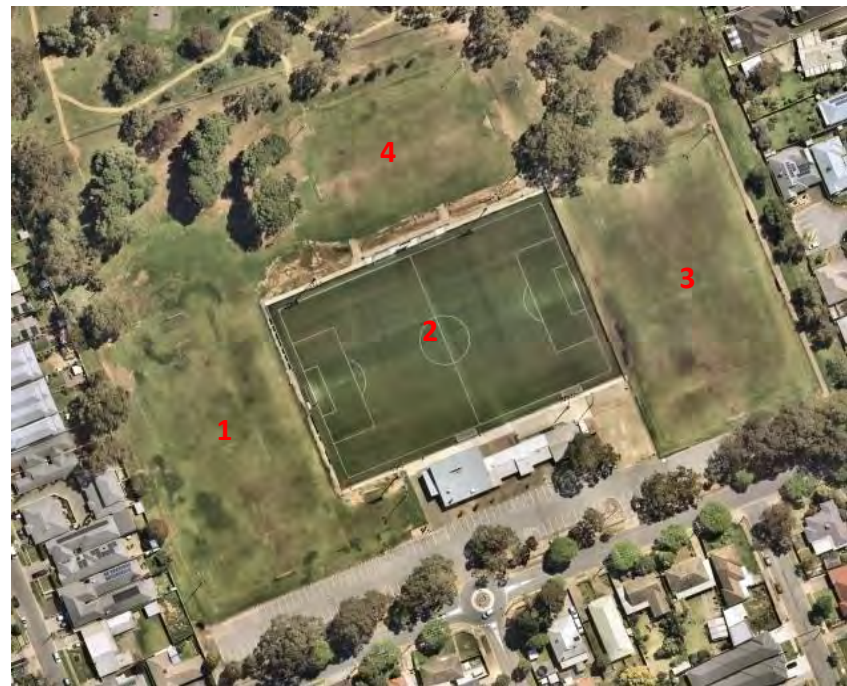
- Soccer building in good condition
- Player amenities are in very poor condition
- Soccer pitches in good to excellent condition

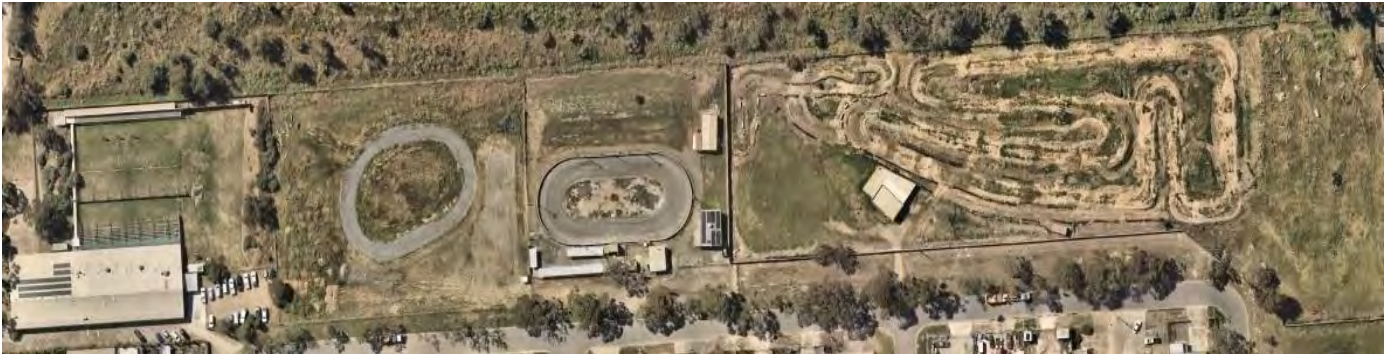
- Speedway tracks in excellent condition
- Rifle range in good condition
