INCLUSIVE SPORTS FACILITIES ASSESSMENT PROJECT

State of Play Report

FEBRUARY 2021

CITY OF
Port Adelaide Enfield

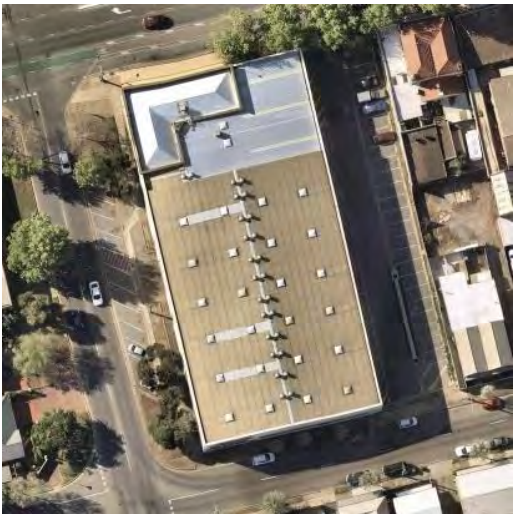
- All courts are compliant with FIBA requirements including run off areas.
- Changerooms are not unisex and player amenities are shared with the public.

Oval Ground Capacity Rating		n/a		
Participation	Basketball SA	2020	2019	2018
	West Adelaide Bearcats	975 630	1115 610	1324 470
Clubs Top 5 Priorities	Basketball SA	<div><div>1. More court space</div><div>2. Toilets and changeroom facilities</div><div>3. Car parking</div><div>4. Amenities</div></div>		
	West Adelaide Bearcats	<div><div>1. Access to a well-located multi-court training facility at times we cannot access our main facility</div><div>2. Development of a new training area within surplus space within the existing main facility (requires some capital investment for reconfiguration & fit-out)</div><div>3. Appointment of paid club manager to take pressure of volunteer committee</div><div>4. Reconfiguration of main facility to increase/provide commercial opportunities for club</div></div>		
Other site comments/ observations		<div><div>• Player amenities include toilets that are shared with the public.</div></div>

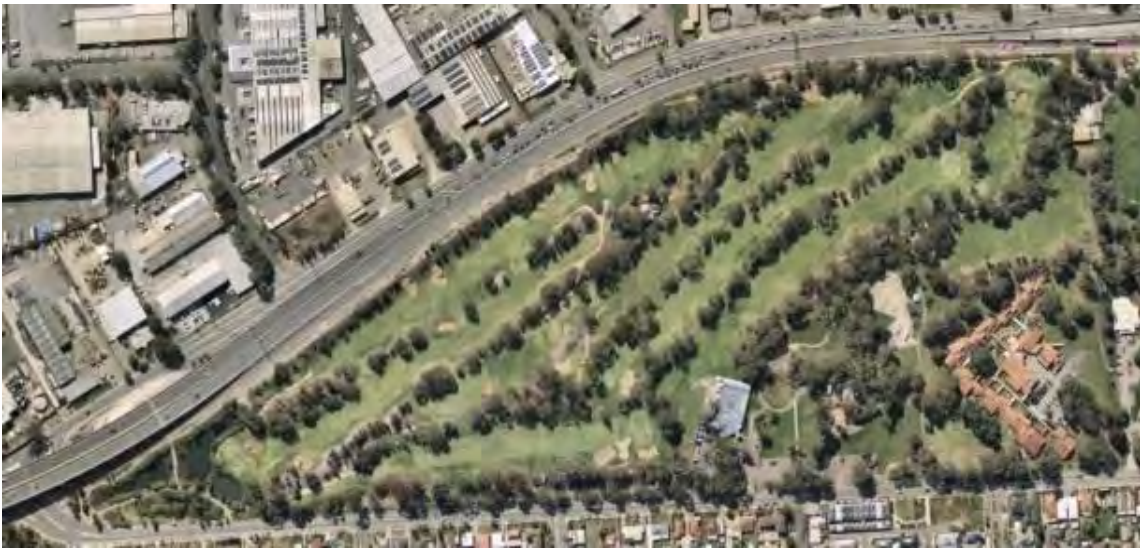
- Small pro shop with kiosk
- Public toilets in moderate condition but need upgrading
- Golf greens in good condition
- Cart storage is in with toilets
- Plans to renovate the Pro shop

MAIN BUILDING		
ASSET	DESCRIPTION	RATING
Kitchen / Kiosk	Servery	3
Social/Function Area	none	-
Internal Storage	Multiple areas 35-40m²	3
Toilets (Within Building)	Male, Female and Accessible	3
Overall Condition of Building	Poor – quality issues and not functional	4
Player Amenities	none	-
Umpire Amenities	none	-

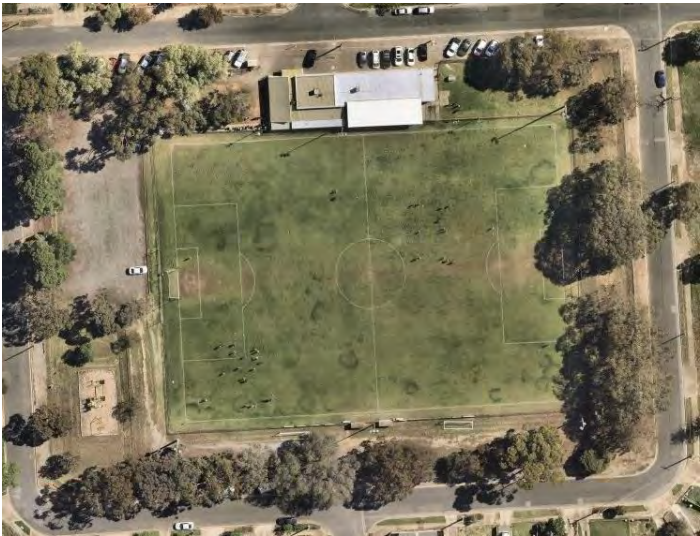
- Playing fields in good condition
- Site fencing in poor condition (holes throughout)

The average light levels (168 Lux) @ (0.56 (U1) uniformity results are above the recommended parameters for “Club Comp and Match Practice”. of 100 lux @ (0.50). From the survey data and general appraisals, Sports Lighting SA have determined that the current lighting system performance Complies with the recommended lighting criteria for “Club Comp and Match Practice”. These levels do however fall just under the requirement of 200 Lux average as per FFSA requirements for Semi -Professional night matches.

MAIN BUILDING / CLUBROOM		
ASSET	DESCRIPTION	RATING
Kitchen / Kiosk	15-19m ²	3
Social/Function Area	150-200m ²	3
Internal Storage	Multiple areas 25-29m ²	3
Toilets (Within Building)	Male, Female and Access	3
Overall Condition of Building	Kitchen not large enough to support functions.	3
Player Amenities	1 x 4 open showers and 1 pan toilet 1 x 3 open showers and 1 pan toilet	3
Umpire Amenities	1 x unisex changeroom (shower and toilet)	2

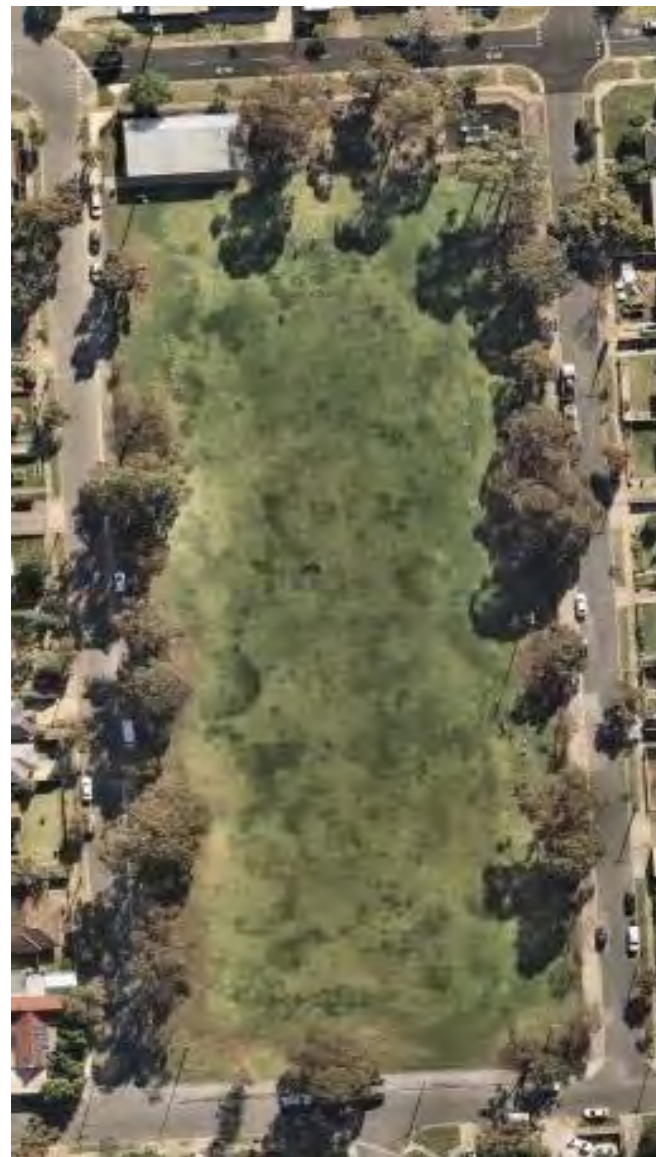
- Building facility in moderate condition.
- Playing field in moderate condition
- Fencing is in moderate condition with damage, curling, slack mesh present

- The playing field is approximately 185m x 68m which complies with Hockey field dimensions of 91.4m in length and 55m wide. A junior pitch could also fit on the remaining area.

MAIN BUILDING / CLUBROOM		
ASSET	DESCRIPTION	RATING
Kitchen / Kiosk	15-19m ²	3
Social/Function Area	100-149m ²	3
Internal Storage	Multiple areas 40m ²	1
Toilets (Within Building)	Male and Female	3
Overall Condition of Building	Moderate – poor visibility to field	3
Player Amenities	1 x 2 open showers and 1 pan toilet 1 x 2 lockable cubicles and 2 pan toilets	4
Umpire Amenities	none	2

PLAYING FIELD		
ASSET	DESCRIPTION	RATING
Surface	Grass	3
Irrigation	Automated	3
Site Fencing	Fully fenced with capacity for restricted access	3

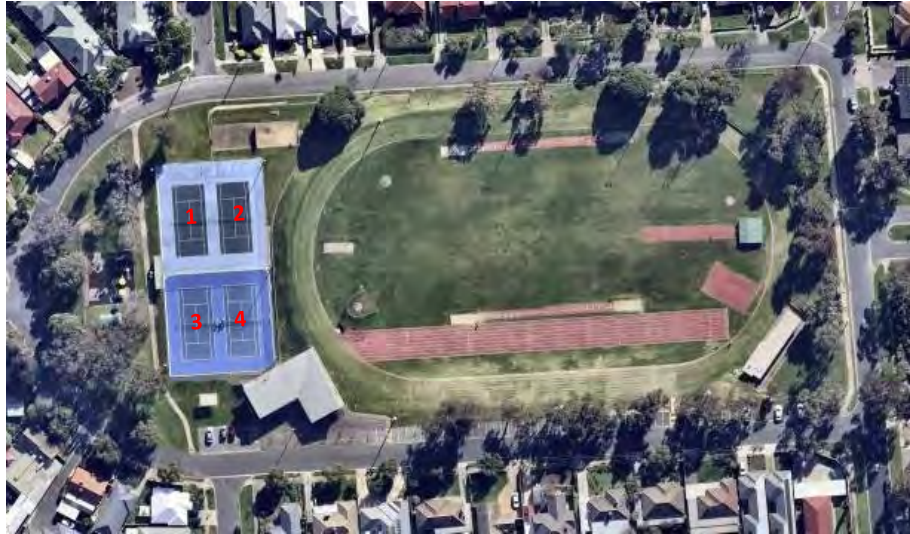
ST ALBANS RESERVE

- Building facility in excellent condition.
- Courts 1 & 2 in good condition, Courts 3 & 4 in excellent condition
- Tennis enclosure fencing in excellent condition

- Tennis courts do not meet the standard for the baseline run off area of 5.48m on all courts, expect the northern baseline of courts 1 & 2
- Athletics audit found the following safety concerns:
 - The height and length of both the Hammer and Discus cages are not compliant and unsafe
 - The Cyclone fence wire that is the covering each cage and the potential of this cover not preventing ricocheting and rebounding of implements
 - The wide openings of both cages as well as the lack of gates on the Hammer cage
 - The depth of the inner throwing circles is too low

MAIN BUILDING / CLUBROOM		
ASSET	DESCRIPTION	RATING
Kitchen / Kiosk	Kiosk 10-14m ²	2
Social/Function Area	100-149m ²	2
Internal Storage	Multiple areas greater than 40m ²	1
Toilets (Within Building)	Male, Female and Access	1
Overall Condition of Building	excellent condition	1
Player Amenities	1 x 1 lockable cubicle and 1 pan toilet 1 x 1 lockable cubicle and 2 pan toilets	1
Umpire Amenities	none	-

PLAYING FIELD		
ASSET	DESCRIPTION	RATING
Surface	Grass	2
Drainage	Good	2
Fencing	none	-

The facility needs to considerably improve the condition of both cages to a level that ensures the safety of all athletes, officials and spectators within the facility

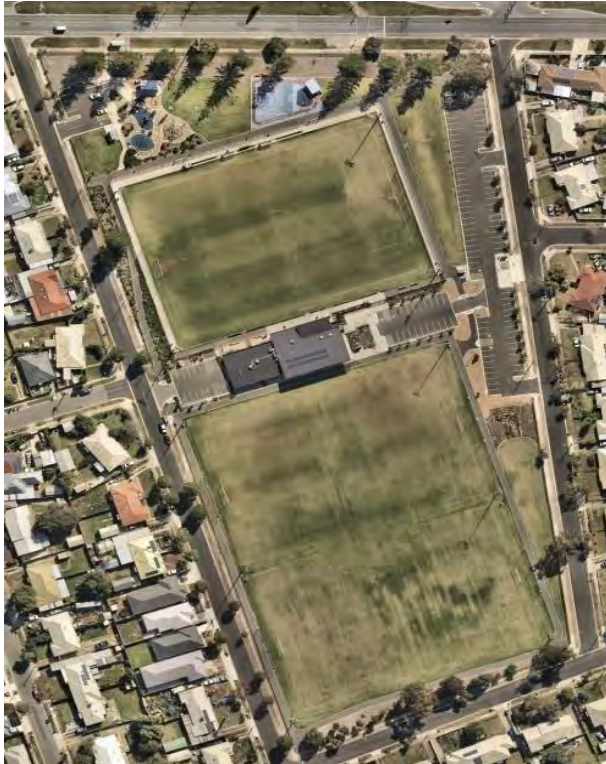
TAPEROO RESERVE

- Soccer building in excellent condition (near new)
- Player amenities are in excellent condition
- Soccer pitches in excellent condition

Grass Pitches - The average light levels @ uniformity results are within the recommended parameters for “Club Comp and Match Practice”. of 100 lux average with the uniformity levels (0.50). Both pitches compare favorably with the original design proposal. From the survey data and general appraisals, Sports Lighting SA have determined that the current lighting system performance Complies with the recommended lighting criteria for “Club Comp and Match Practice”.

Show Pitch - The average light levels @ uniformity results are Much higher than the recommended parameters for “Semi-Professional”. of 200 lux average with the uniformity levels (0.60). From the survey data and general appraisals, Sports Lighting SA have determined that the current lighting system performance Complies with the recommended lighting criteria for “Semi-pro”.

MAIN BUILDING / CLUBROOM		
ASSET	DESCRIPTION	RATING
Kitchen / Kiosk	Greater than 40m ²	1
Social/Function Area	Greater than 200m ²	1
Internal Storage	Multiple areas greater than 40m ²	1
Toilets (Within Building)	Male, Female, Unisex and Access	1
Overall Condition of Building	Excellent – near new	1
Player Amenities	2 x changerooms with 4 lockable cubicles and 2 pan toilets 2 x changerooms with 3 lockable cubicles and 2 pan toilets	1
Umpire Amenities	1 x unisex (1 shower and 1 pan toilet)	1

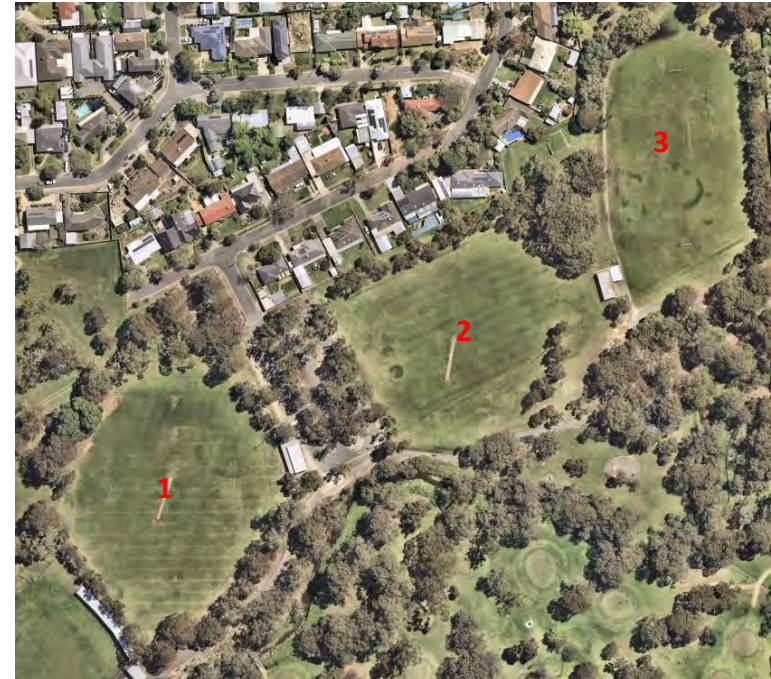
- Soccer change facilities are not compliant as they are not unisex and only have 1 toilet in each. Umpire change facility doesn't include a shower or toilet.
- Playing field 1 is approximately 100m x 69m which complies with minimum dimensions for senior soccer (Length: Minimum 90m, maximum 120m and width: Minimum 45m maximum 90m). Community Club Cricket (Open Age) recommends a 50m radius which fits on the playing field.
- Playing field 2 is approximately 113m x 70m which could fit 2 junior pitches. Community Club Cricket (Open Age) recommends a 50m radius which fits on the playing field.
- Playing field 3 is approximately 97m x 70m which complies with minimum dimensions for senior soccer (Length: Minimum 90m, maximum 120m and width: Minimum 45m maximum 90m).
- No Scoreboards present
- No cricket training facility

Playing field 1 - The results show that the average illuminance values are not favourable to the required standard for Ball & physical training & results do not comply to the specified Light Technical Parameters recommended in AS2560.2.3-2007.

Oval Ground Capacity Rating	Medium		
Participation	2020	2019	2018
Valley View Soccer Club	33	60	80
Adelaide Pumas Soccer Club	50	60	60
Clubs Top 5 Priorities			
Valley View Soccer Club	<ol style="list-style-type: none"> 1. Upgrade to building facility 2. Floodlighting on alternative pitches 3. Increased promotion within the local schools system 4. The establishment of a facility that caters for more female friendly change rooms and child safe environment 5. Not having to share the facility with adult sports clubs and compete for training nights 		
Adelaide Pumas Soccer Club	<ol style="list-style-type: none"> 1. Game Pitch to be repaired 2. Facilities to have an upgrade. 3. Showers in change room to be looked at and repaired 		
Other site comments/ observations	<ul style="list-style-type: none"> • Large open space that caters for soccer and cricket • Buildings in poor condition and should be redeveloped

MAIN BUILDING / CLUBROOM – PUMAS		
ASSET	DESCRIPTION	RATING
Kitchen / Kiosk	15-19m ²	3
Social/Function Area	Less than 50m ²	4
Internal Storage	none	-
Toilets (Within Building)	Male, Female and Access	2
Overall Condition of Building	Poor (multiple issues)	4
Player Amenities	1 x 4 open showers and no toilets 1 x no showers or toilets	5
Umpire Amenities	1 x no shower and 1 pan toilet	5

MAIN BUILDING / CLUBROOM – VALLEY VIEW		
ASSET	DESCRIPTION	RATING
Kitchen / Kiosk	Kiosk 10-14m ²	3
Social/Function Area	Less than 50m ²	4
Internal Storage	10-14m ²	3
Toilets (Within Building)	Male, Female and Access	2
Overall Condition of Building	Poor (multiple issues)	4
Player Amenities	none	-
Umpire Amenities	none	-

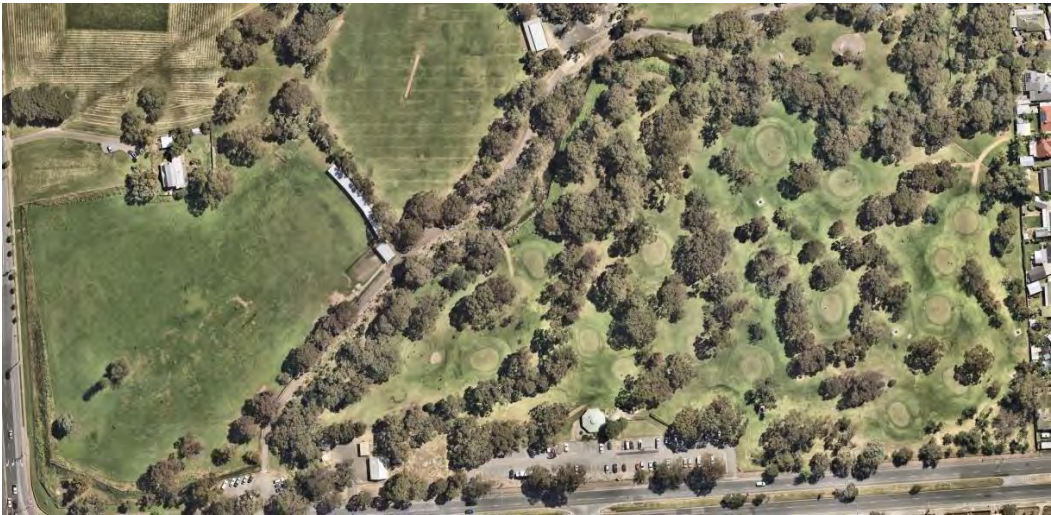
- Small pro shop with a few tables and seating
- Public toilets in good condition and act as access toilets too
- Golf greens in good condition

MAIN BUILDING		
ASSET	DESCRIPTION	RATING
Kitchen / Kiosk	10-14m ²	2
Social/Function Area	Less than 50m ²	3
Internal Storage	Multiple areas 15-19m ²	3
Toilets (Within Building)	Male, Female and Accessible	2
Overall Condition of Building	Social space includes pro shop	3
Player Amenities	none	-
Umpire Amenities	none	-

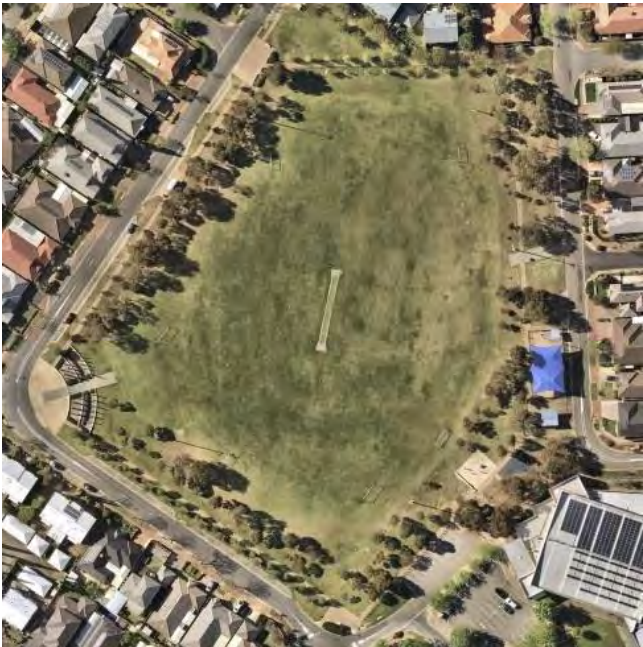
The results show that the average illuminance values are not favourable to the required standard for Ball & physical training & results do not comply to the specified Light Technical Parameters recommended in AS2560.2.3-2007.

PLAYING FIELD		
ASSET	DESCRIPTION	RATING
Surface	Grass	2
Irrigation	Automated	2
Site Fencing	none	-
