Dry Creek

Management Plan

City of Port Adelaide Enfield

Prepared by EBS Ecology for the City of Port Adelaide Enfield

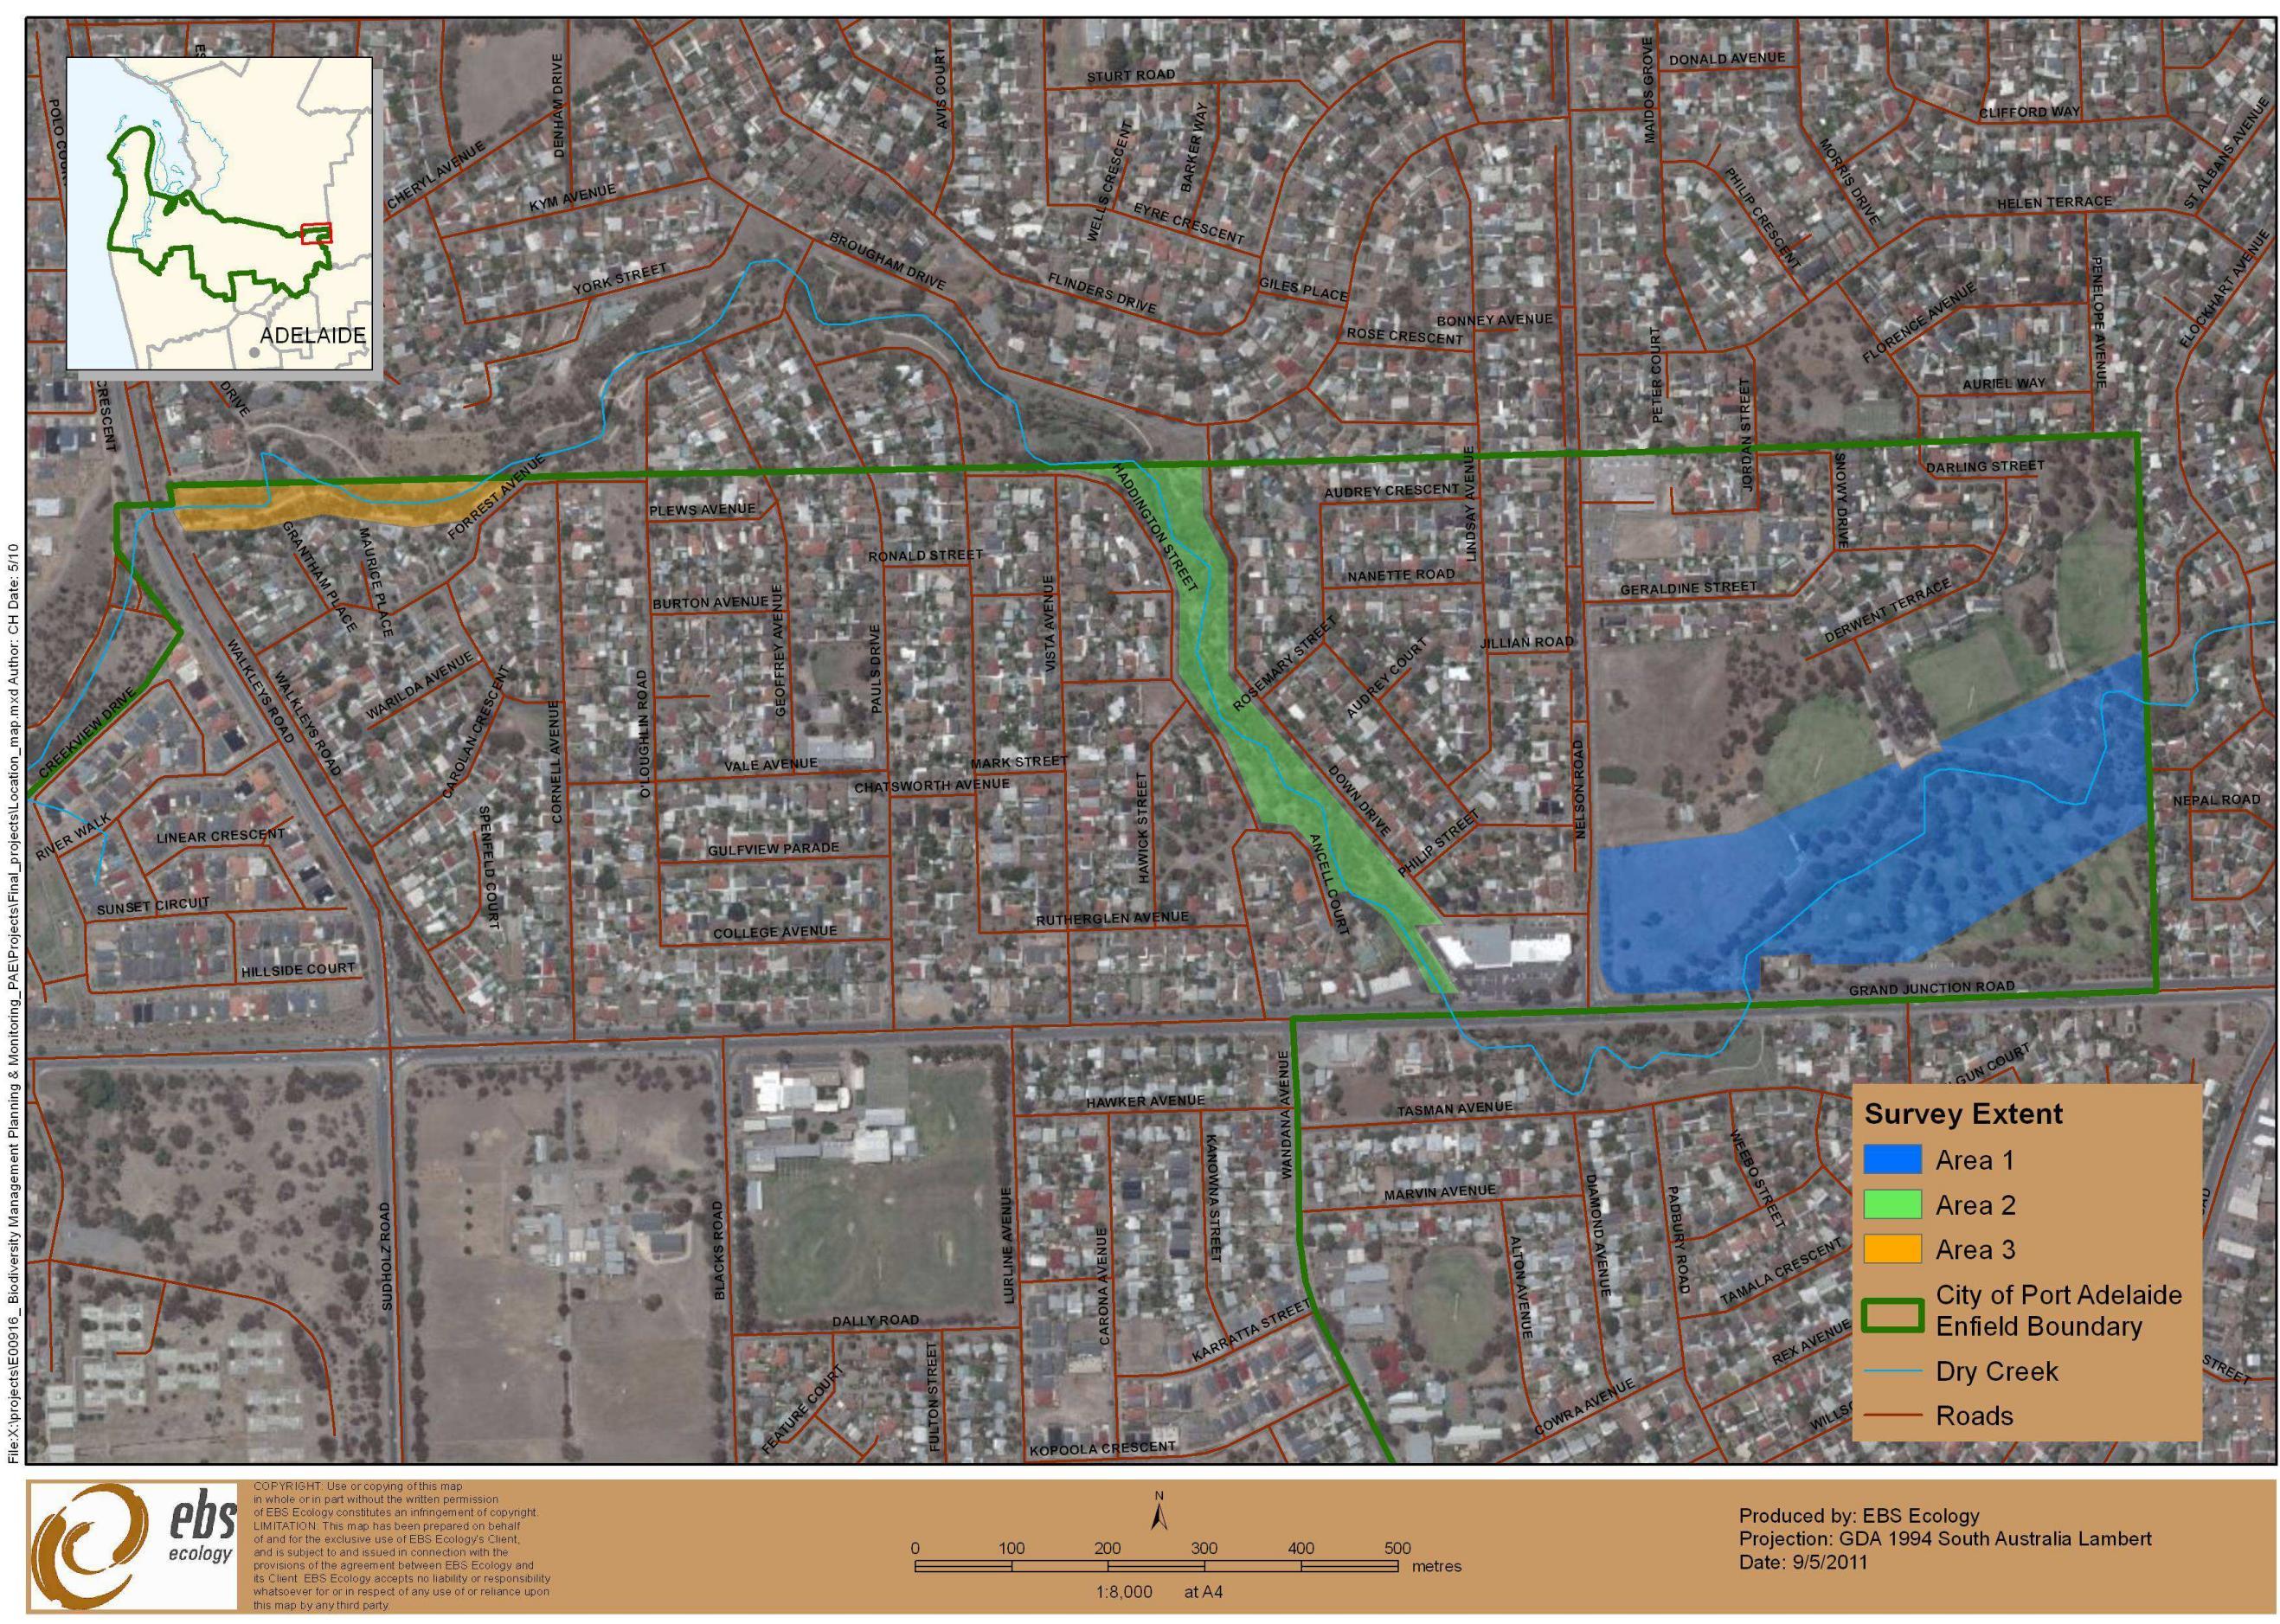
Figure 1. Project Area.

Figure 1 details the project area separated into three distinct management areas forming the basis for all management actions.

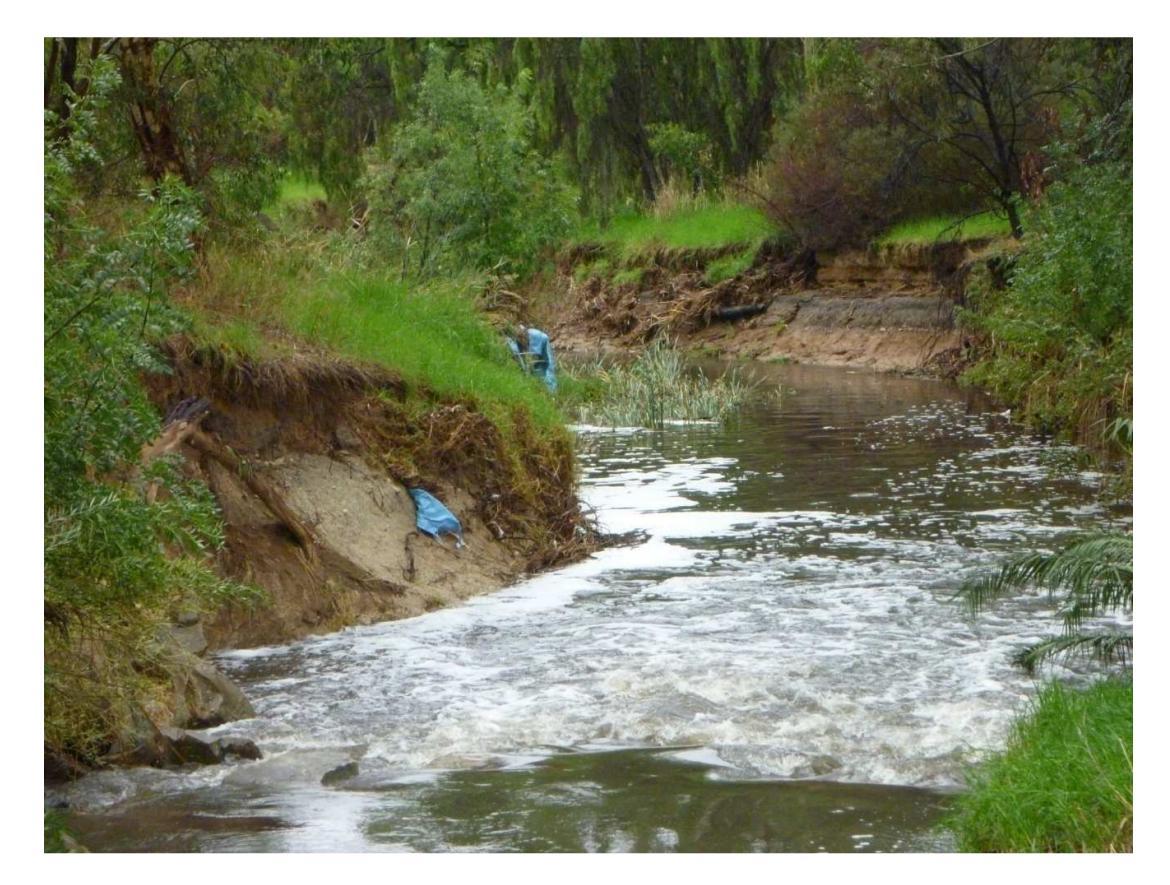
Figure 3. Erosion resulting from heavy rainfall event.

Serious erosion issues were observed within Dry Creek during the field survey. Heavy rain events prior to the field survey had resulted in considerable erosion to the creek banks (Refer Figure 3). New housing developments coupled with an increase in subdivisions of existing house blocks have reduced open areas of land that previously assisted in absorbing rainfall into the subsurface soil structure. The result is an increase in stormwater runoff entering Dry Creek and the velocity at which it enters.

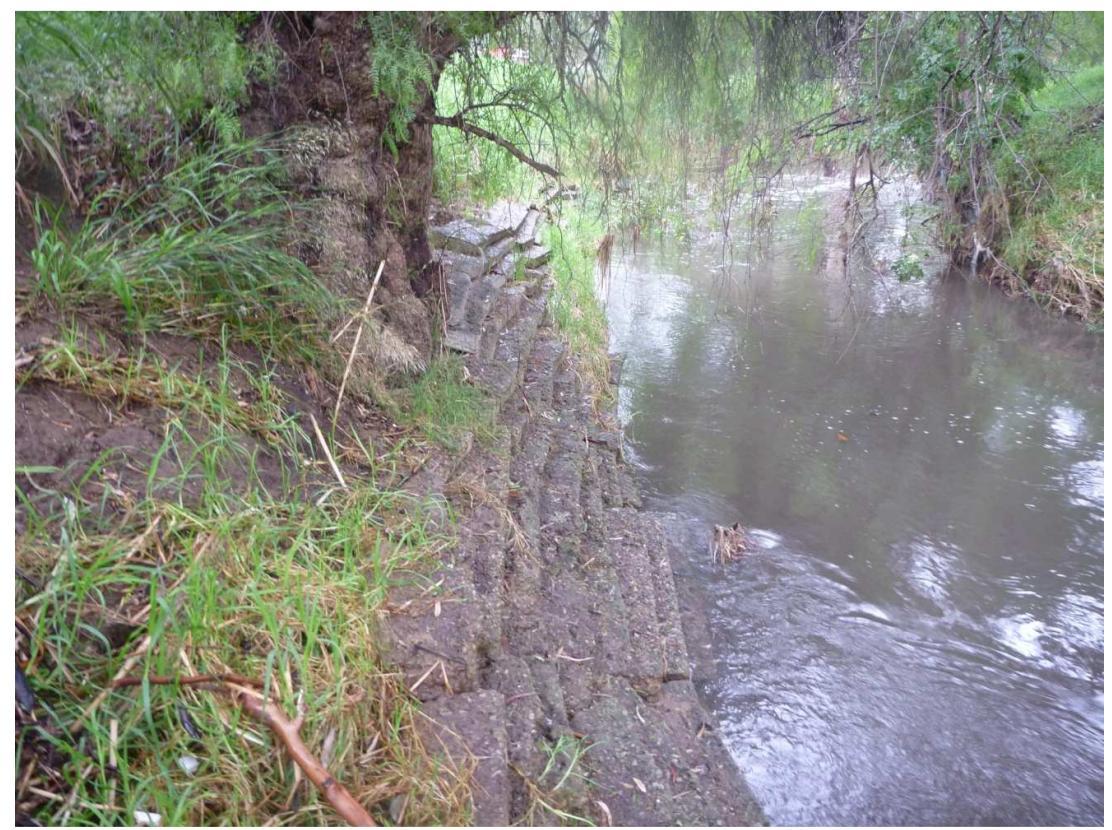
Figure 4. Erosion mitigation structure along creek bank.

One location within the project area has had an erosion mitigation structure installed along the creek bank. This structure consisted of a tiered concrete wall extending down the creek bank into the creek. (Refer Figure 4).

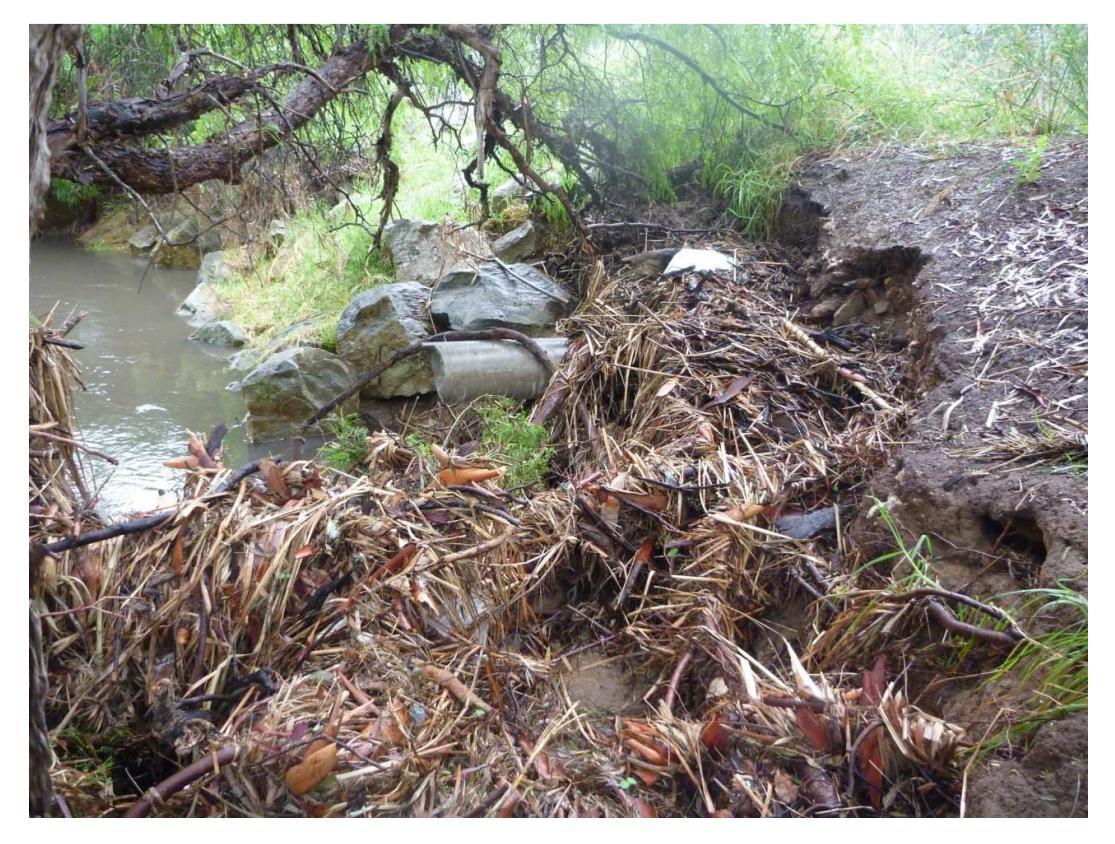
Figure 5. Erosion damage around stormwater outlet pipe.

Several stormwater outlets were situated within the Dry Creek project area. Most outlets consisted of a single concrete pipe discharging directly into Dry Creek. Active erosion was noted at a large proportion of these outlet pipes during the field survey, (Refer Figure 5). Several stormwater outlets had erosion mitigation structures retrofitted at the point of entry into the creek. These included concrete steps (Figure 6) and concrete and rock surrounding wall (Figure 7). It was noted that erosion was less prevalent at outlets fitted with erosion mitigation structures.
